Comparative Fire Resistance of Roofing Materials

Published by
Shingle Branch, West Coast Lumbermen's Association
Seattle, Wash.

Test of Roofing Materials to Determine their Comparative Fire Resistance

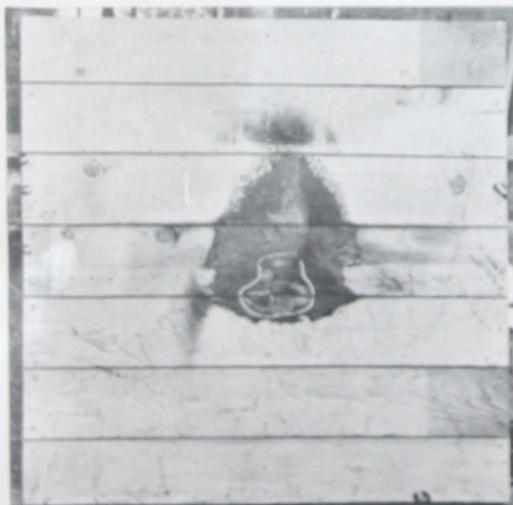
No. 1—Showing damage done to sheathing.

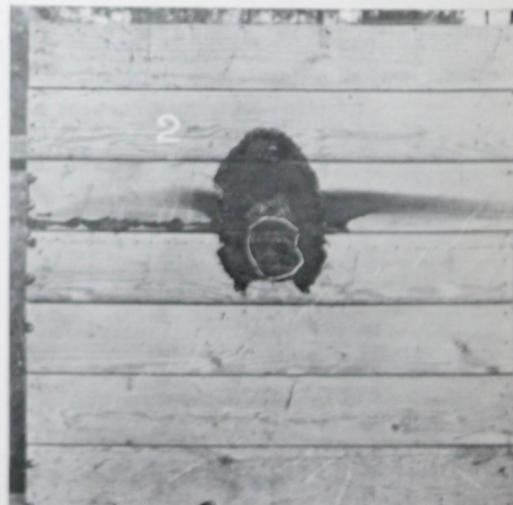
No. 2—Showing damage done to sheathing.

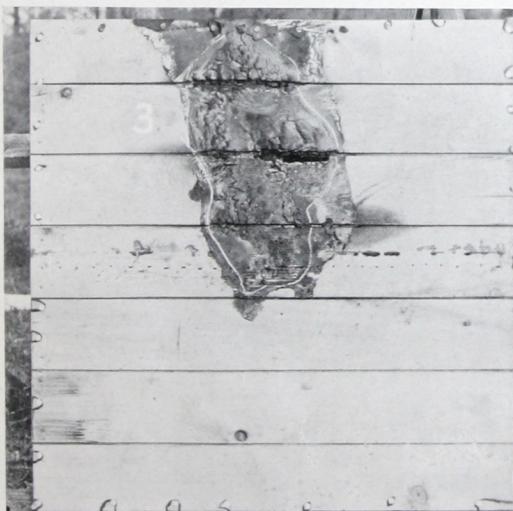
No. 3—Showing damage done to sheathing.

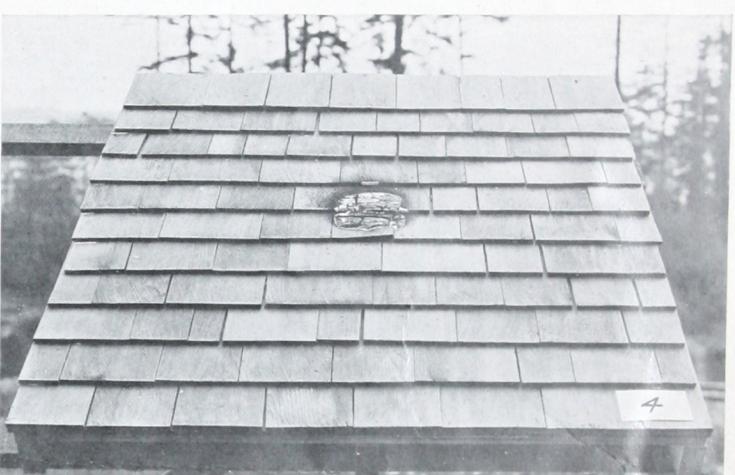
No. 4—Above roof after fire had burned itself out.

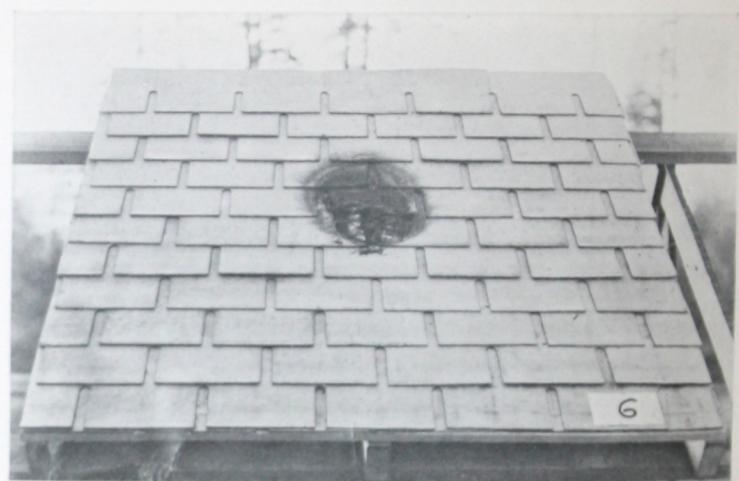
No. 6—Above roof after fire had burned itself out.

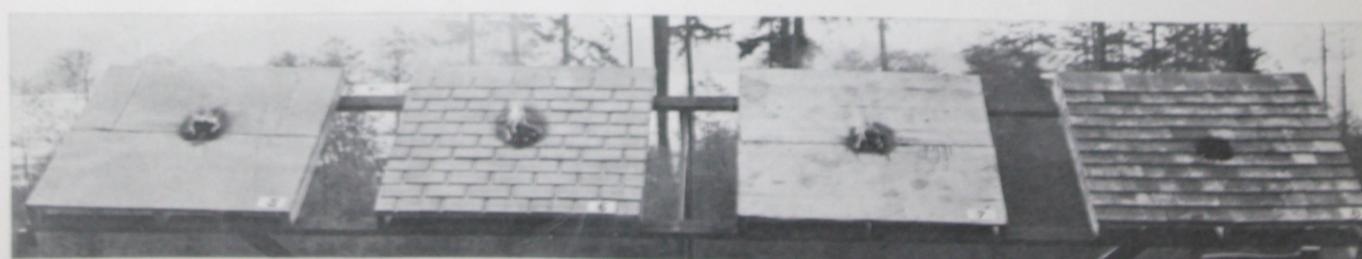
Nos. 5, 6, 7 and 8 Roofs, 7 minutes and 30 seconds after ignition.

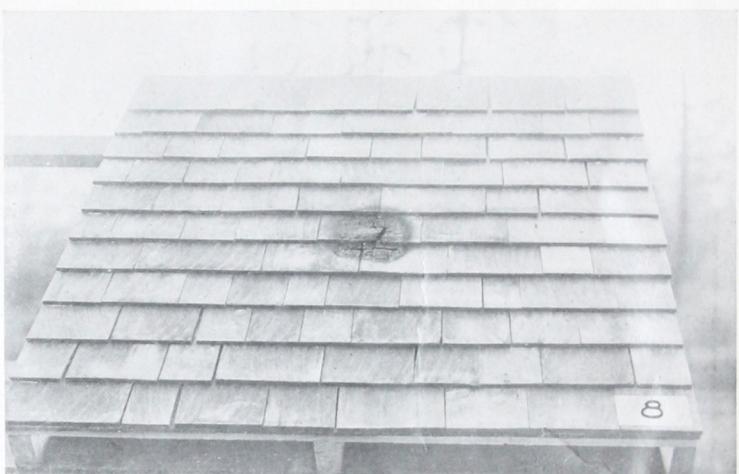
No. 8—Above roof after fire had burned itself out.

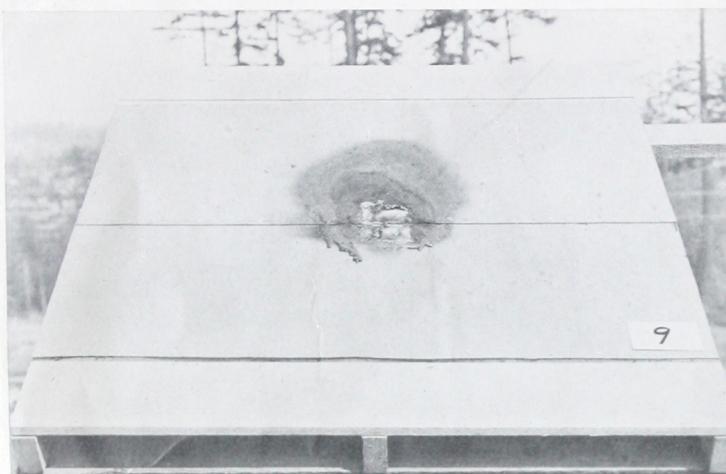
No. 9—Above roof after fire had burned itself out.

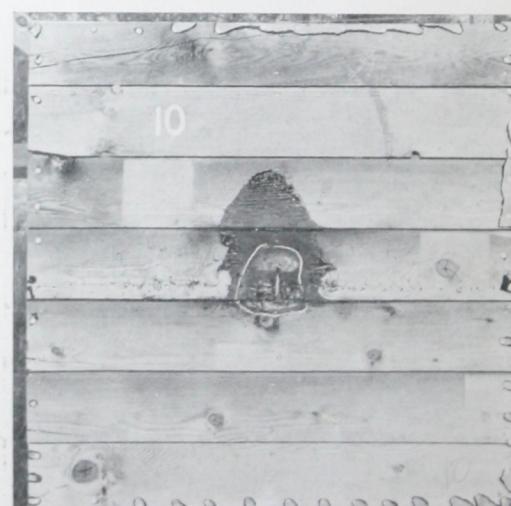
No. 10—Showing damage done to sheathing.

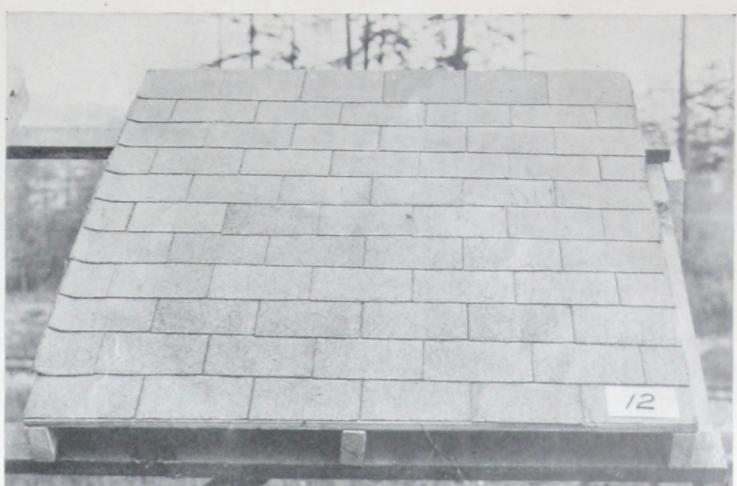
No. 12—High grade patent shingles. Before ignition.

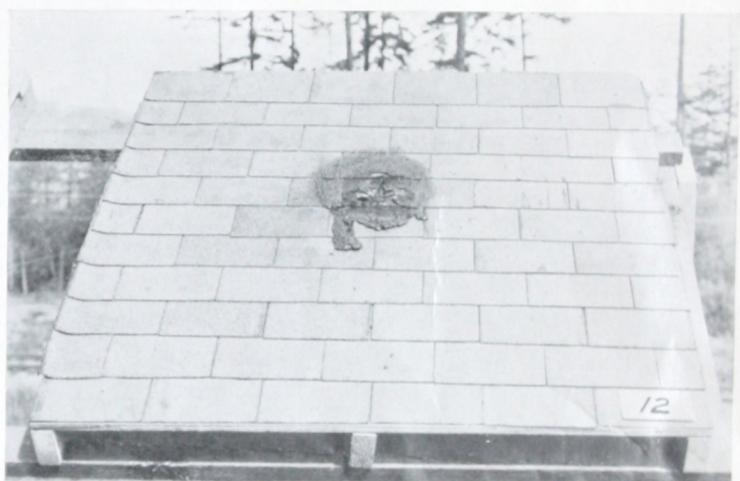
No. 12—Above roof after fire had burned itself out.

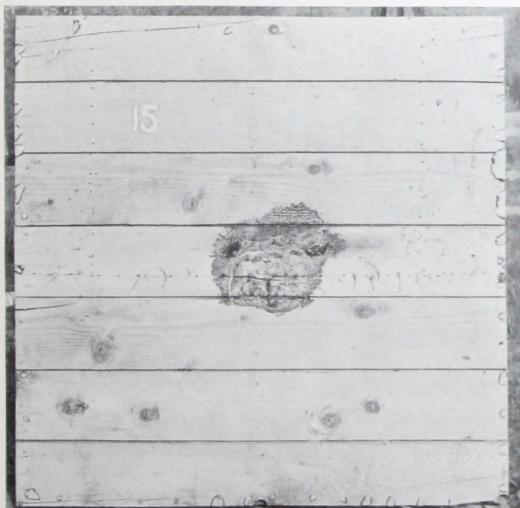
No. 15—Showing damage done to sheathing.
